Danish Maritime Accident
Investigation Board

MARINE ACCIDENT REPORT

AARSLEFF JACK III / WESTSUND / JOHANNA
Breakdown and collision on 18 December 2011

Joint investigation report by the flag State of the United Kingdom and the flag State of Denmark in accordance with the IMO Casualty Investigation Code (resolution MSC.255(84))

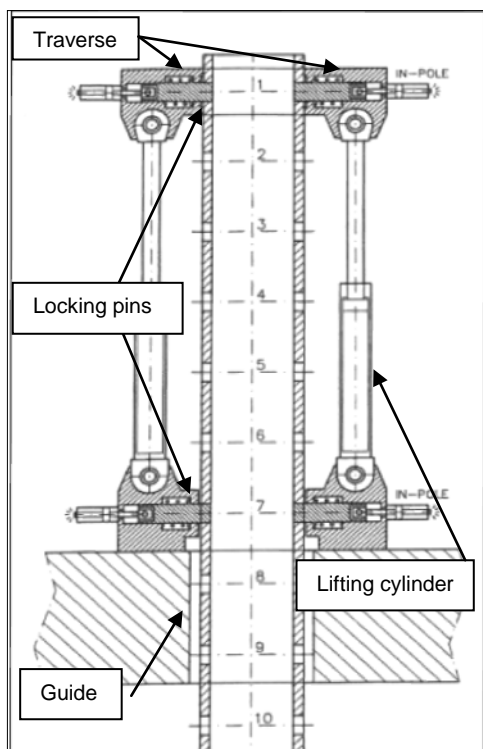
Figure 5: Jack-up unit
Source: Aarsleff A/S

In the figure, the hydraulic jack and spud pile is illustrated in a locked position.

The four locking pins are pushed into the spud pile by means of steel springs with a force of about 980 N. By applying hydraulic pressure, the pins are brought back and thereby release the spud pile.

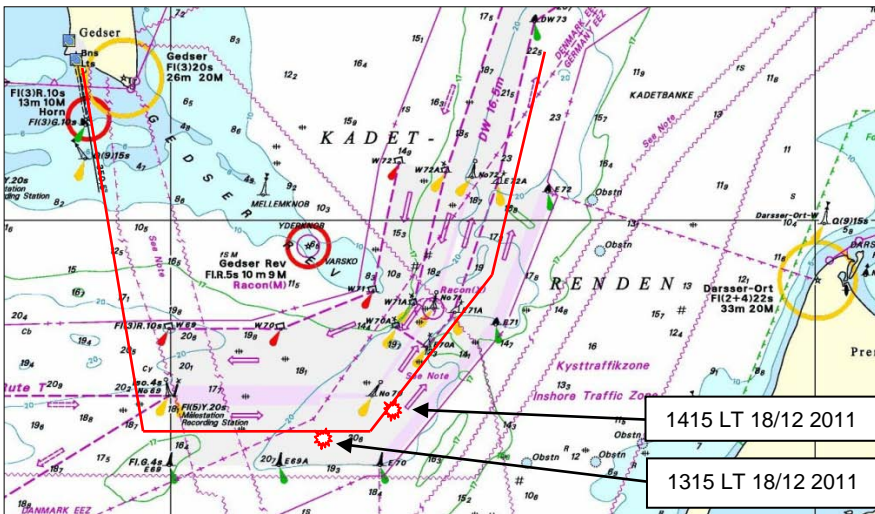
Figure 6: Overview of Kadetrenden
Source: Det Levende Søkort

On 28 December 2011, a search for the missing spud piles and pontoon was initiated by the Waterways and Shipping Directorate and carried out by the Federal Maritime and Hydrographic Agency in Germany. By means of a side-scan sonar, the spud piles were located at approximately 20 metres depth on the positions marked 1315 and 1415 on figure 6.

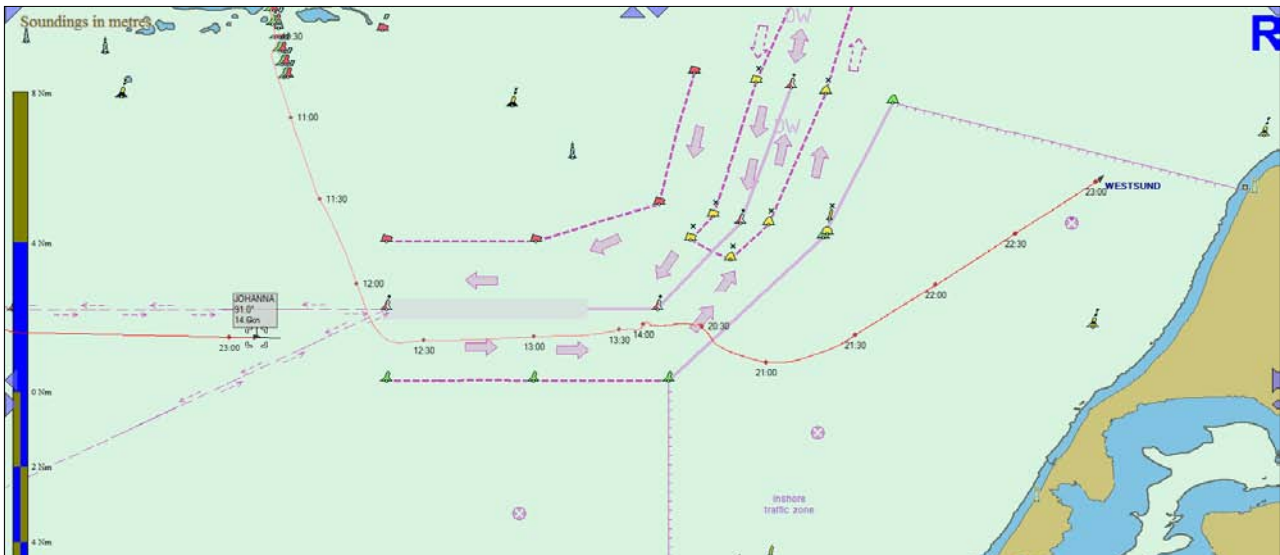
Figure 8: AIS track of WESTSUND
Source: Danish Maritime Authority

At 2041, Warnemünde VTS called WESTSUND again for an update. It was reported that everything was well secured and that they would go to a sheltered position near the German coast and wait for better weather. See figure 8 below of WESTSUND's AIS track.

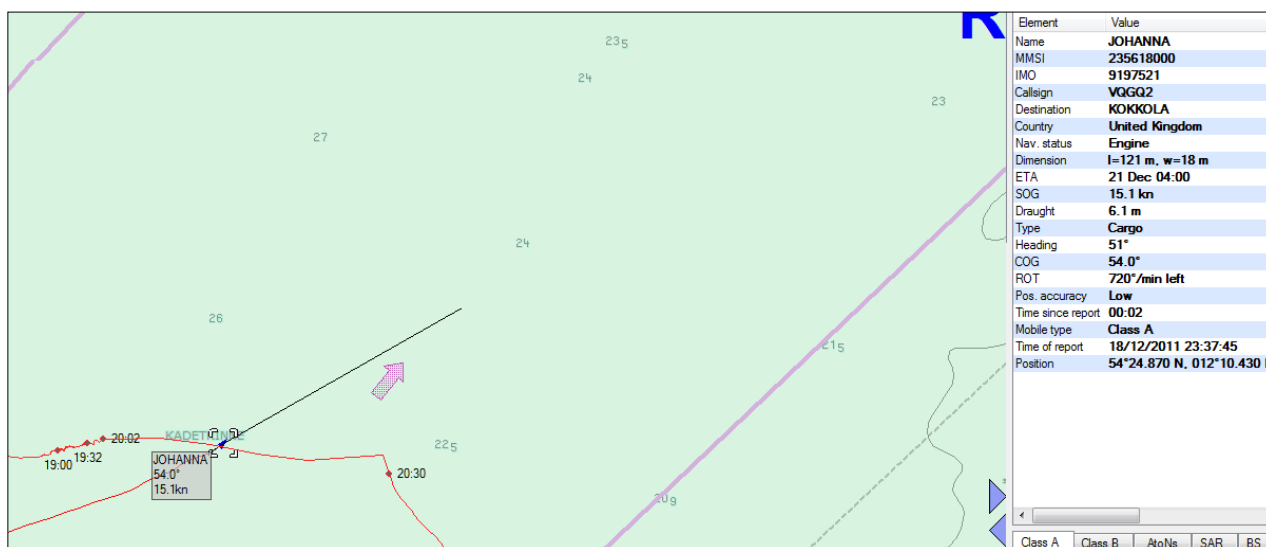
Figure 16: AIS track JOHANNA and WESTSUND
Source: Danish Maritime Authority

The AIS track shows JOHANNA on a northeasterly course on 18 December 2011 at 2337 local time, crossing the track of WESTSUND's easterly course approximately 2.5 hours after WESTSUND was in about the same position.
